Pictures 1-2 – Champlainside Farm, Bridport, VT – 4/19/12
New PVC pipe to capture roof runoff at the heifer barn.
Animal path from the heifer barn to an open exercise lot.

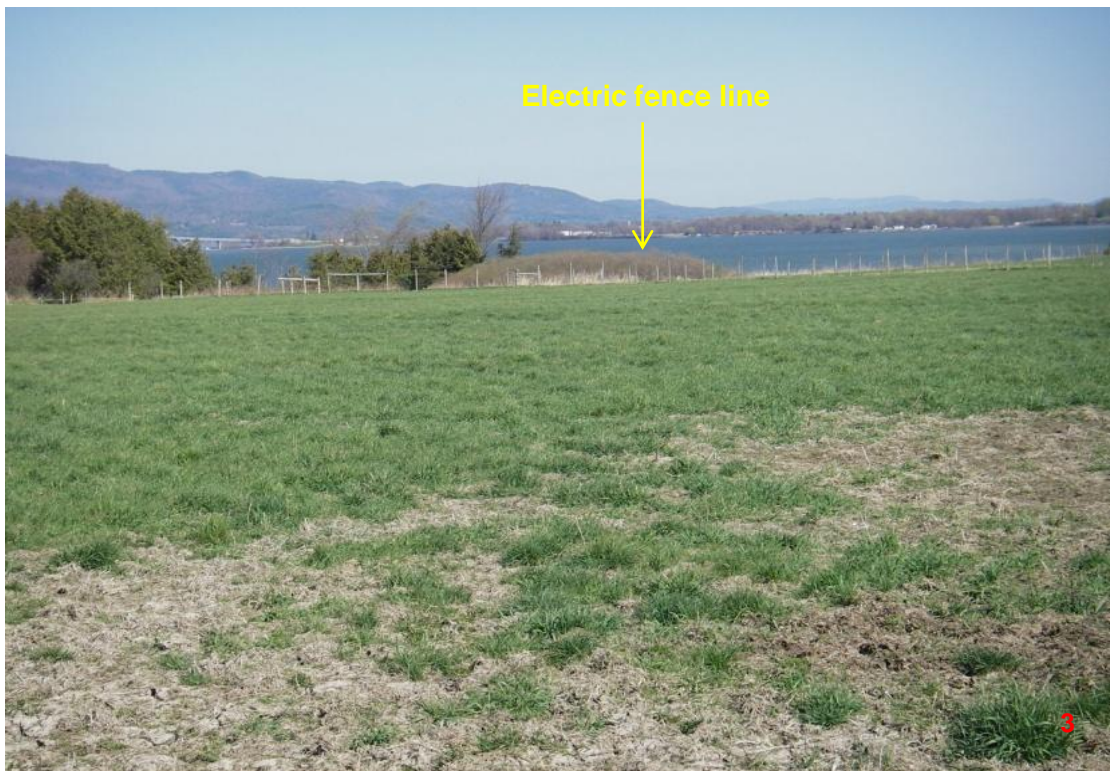
Picture 3 – Champlainside Farm, Bridport, VT – 4/19/12
Open exercise lot next to Lake Champlain with fencing in place.

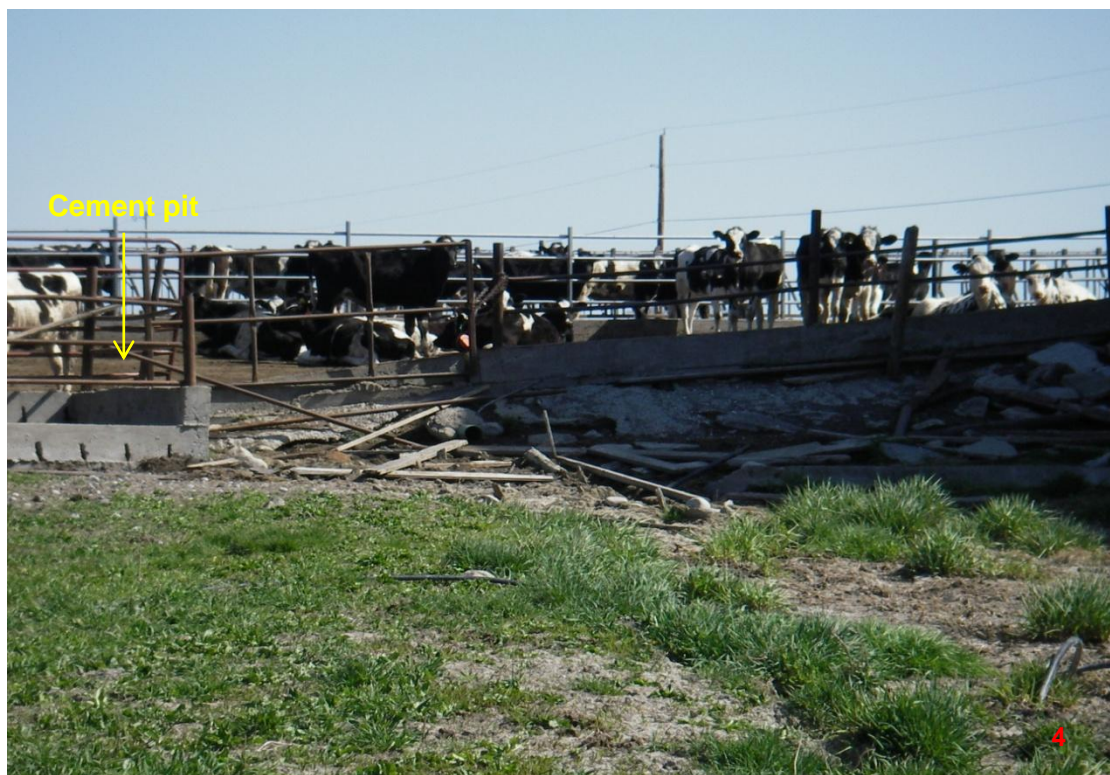
Picture 4 – Champlainside Farm, Bridport, VT – 4/19/12
View of the heifer barnyard.

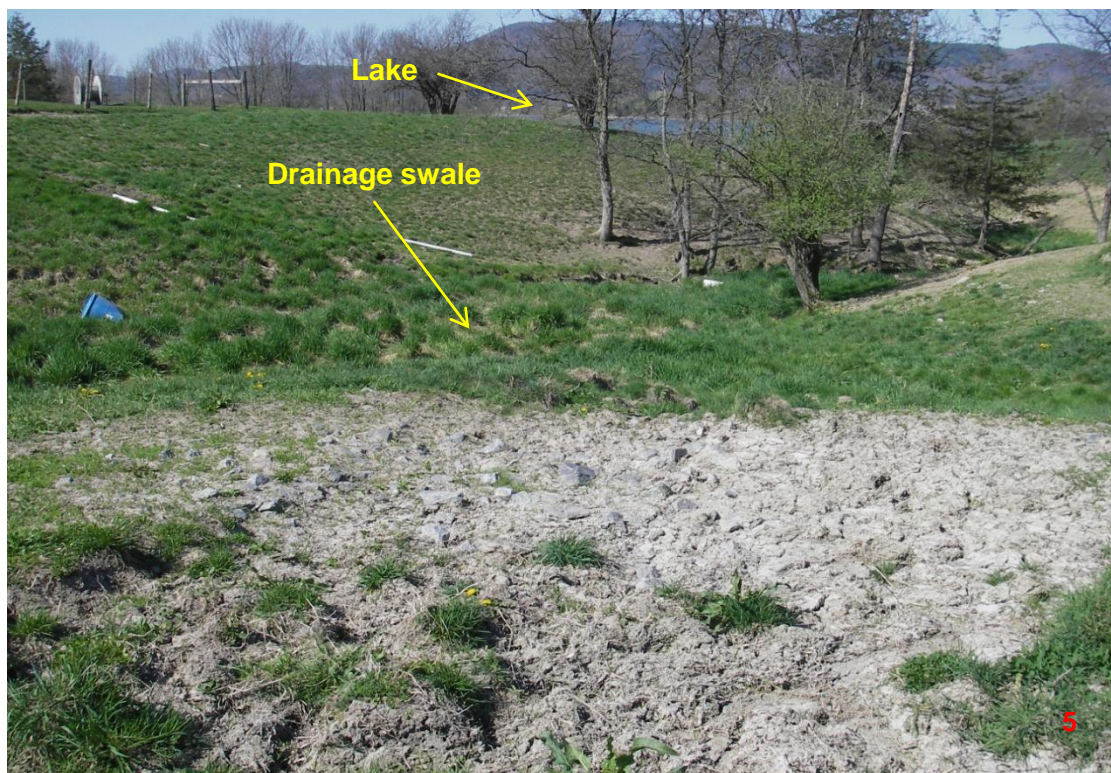
Picture 5 – Champlainside Farm, Bridport, VT – 4/19/12
Dried manure/solids on a slope below the heifer barnyard.

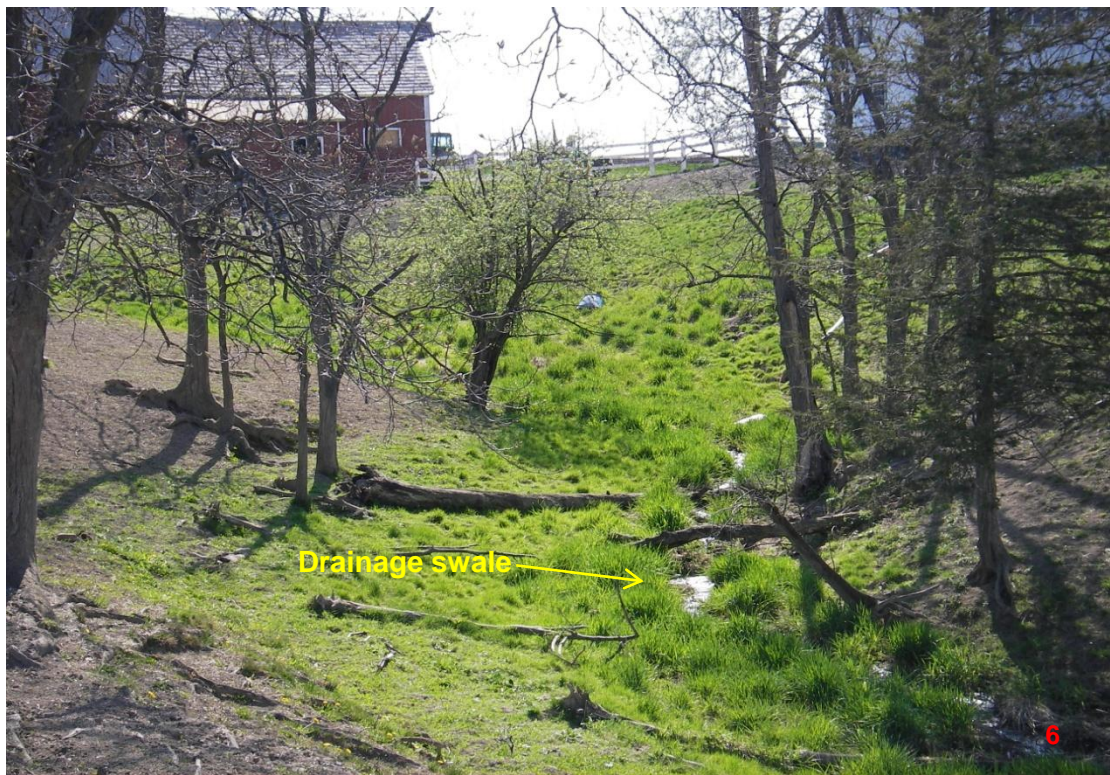
Picture 6 – Champlainside Farm, Bridport, VT – 4/19/12
Natural drainage swale that flows west to Lake Champlain, looking toward the farm.

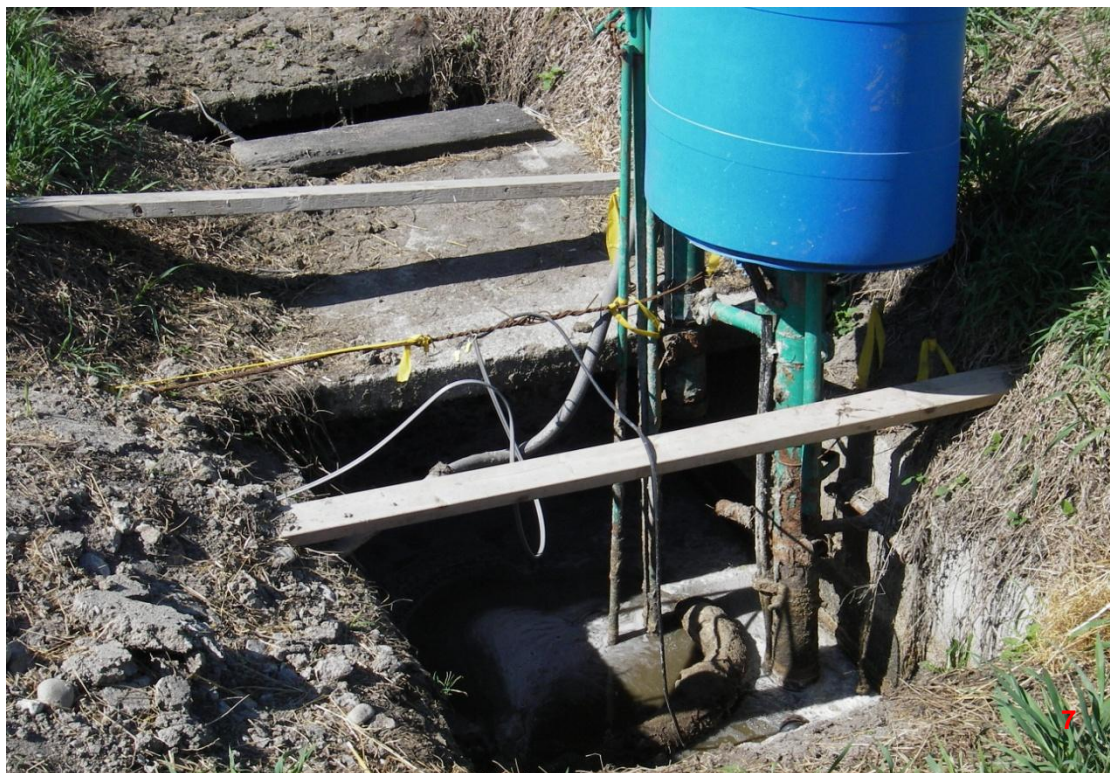
Picture 7 – Champlainside Farm, Bridport, VT – 4/19/12
Sump/pit for milk parlor wastewater.

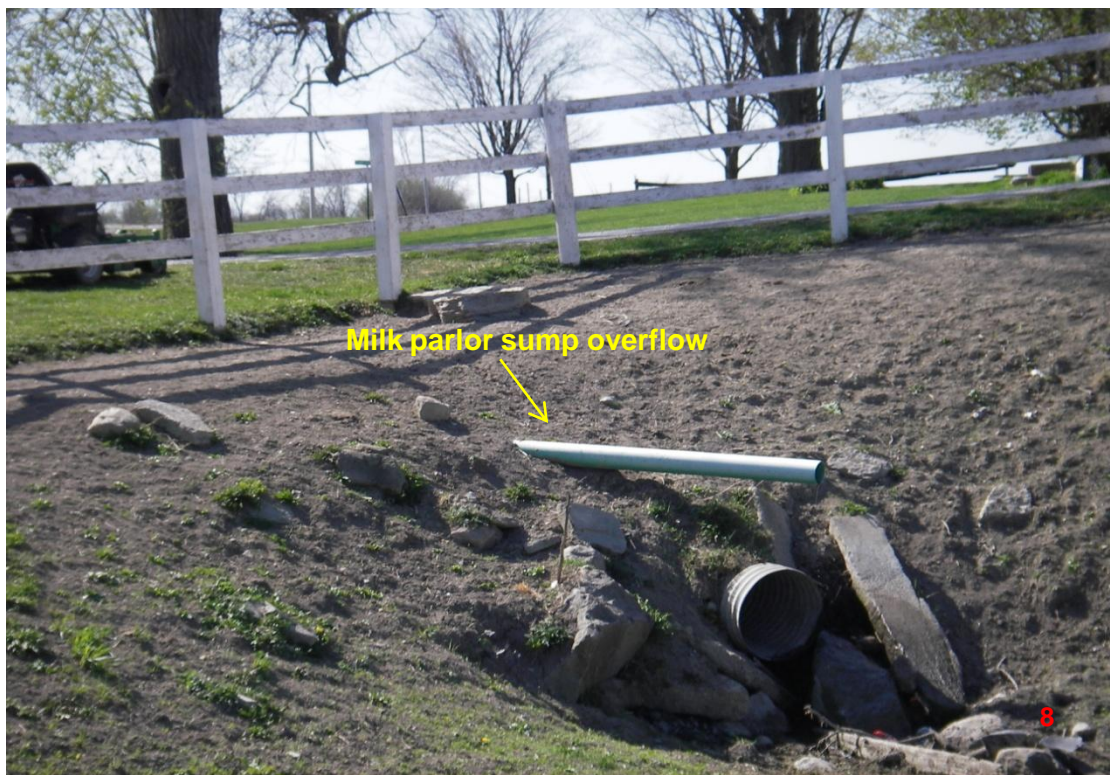
Picture 8 – Champlainside Farm, Bridport, VT – 4/19/12
PVC discharge pipe for milk sump/pit overflow. (Corrugated pipe collects drainage from Lake St.)

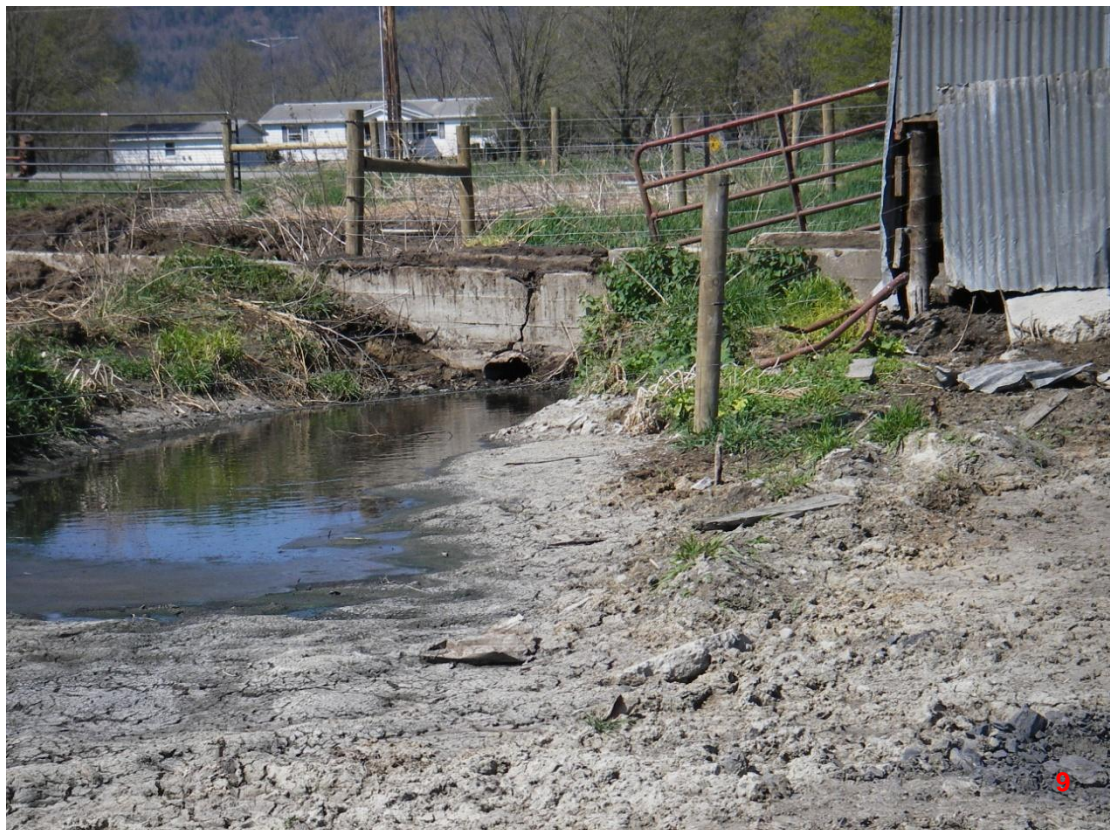
Picture 9 – Champlainside Farm, Bridport, VT – 4/19/12
Accumulation of manure, liquids in a culvert area behind the milking barn.

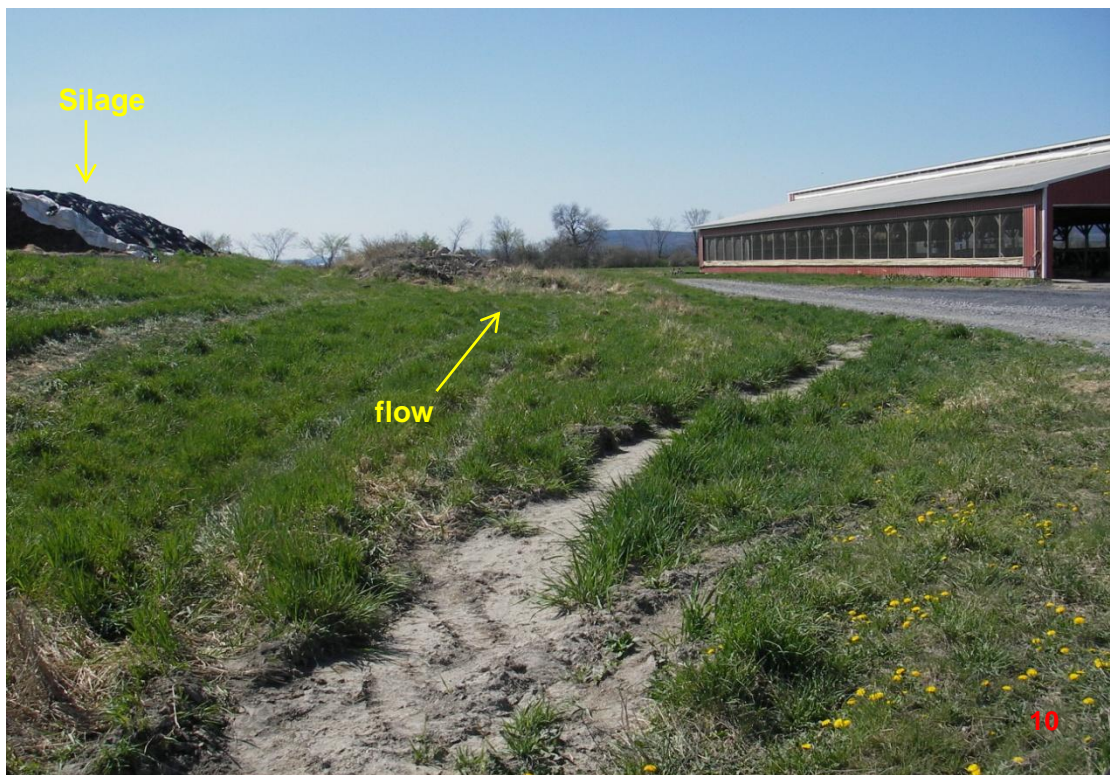
Picture 10 – Champlainside Farm, Bridport, VT – 4/19/12
 Silage runoff flows south around the dry cow barn to a vegetated drainage ditch.

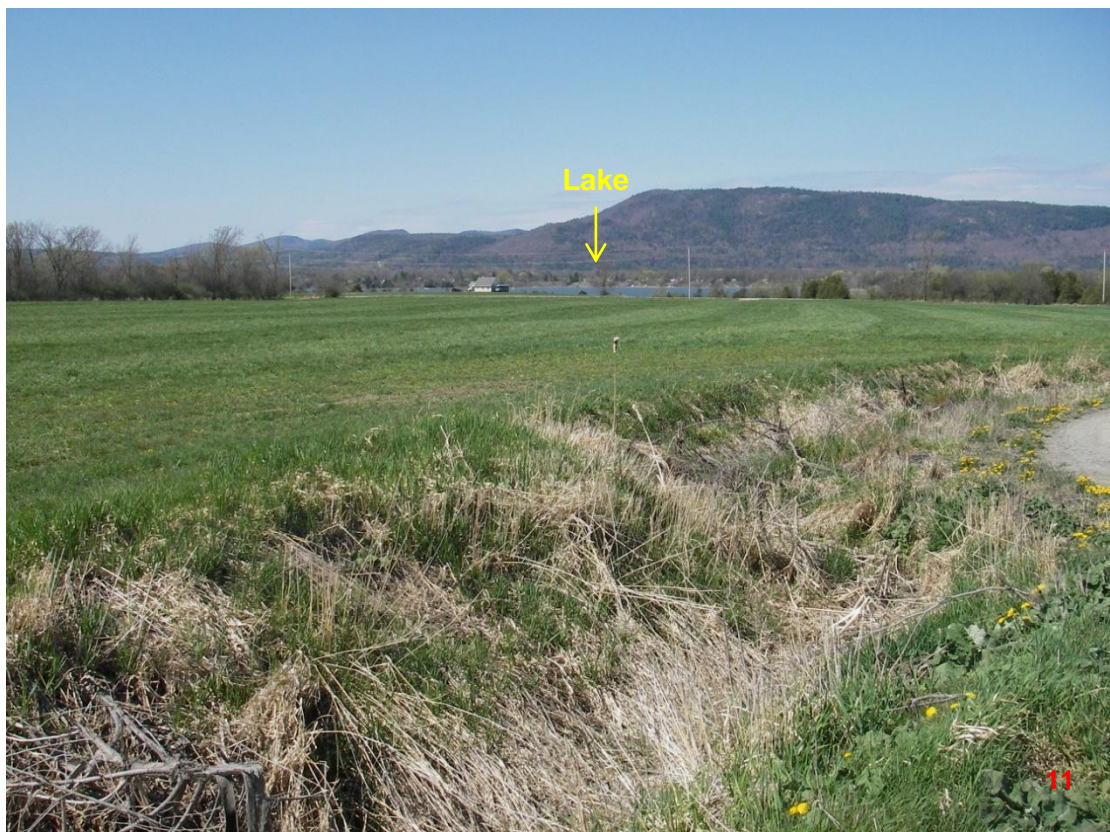
Picture 11 – Champlainside Farm, Bridport, VT – 4/19/12
 Vegetated drainage ditch and grassy field that receives runoff from the southeast silage bunkers.

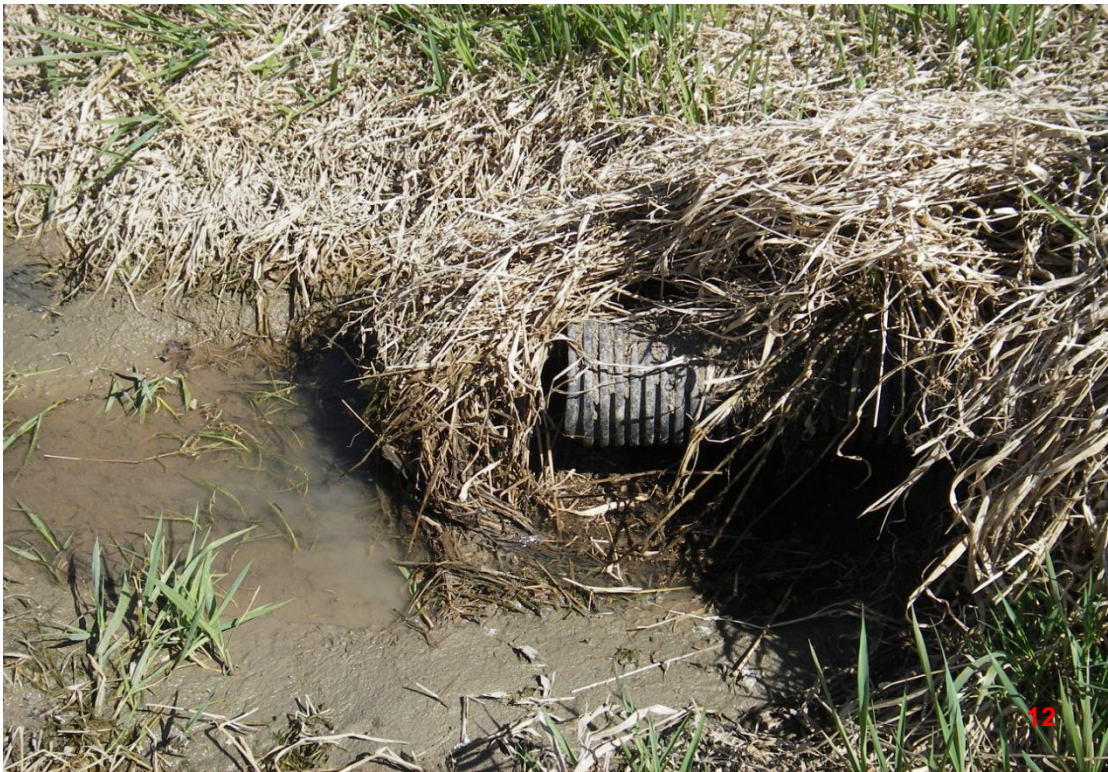
Picture 12 – Champlainside Farm, Bridport, VT – 4/19/12
Discharge from tile drains in adjacent fields into a second drainage ditch in the grassy field.

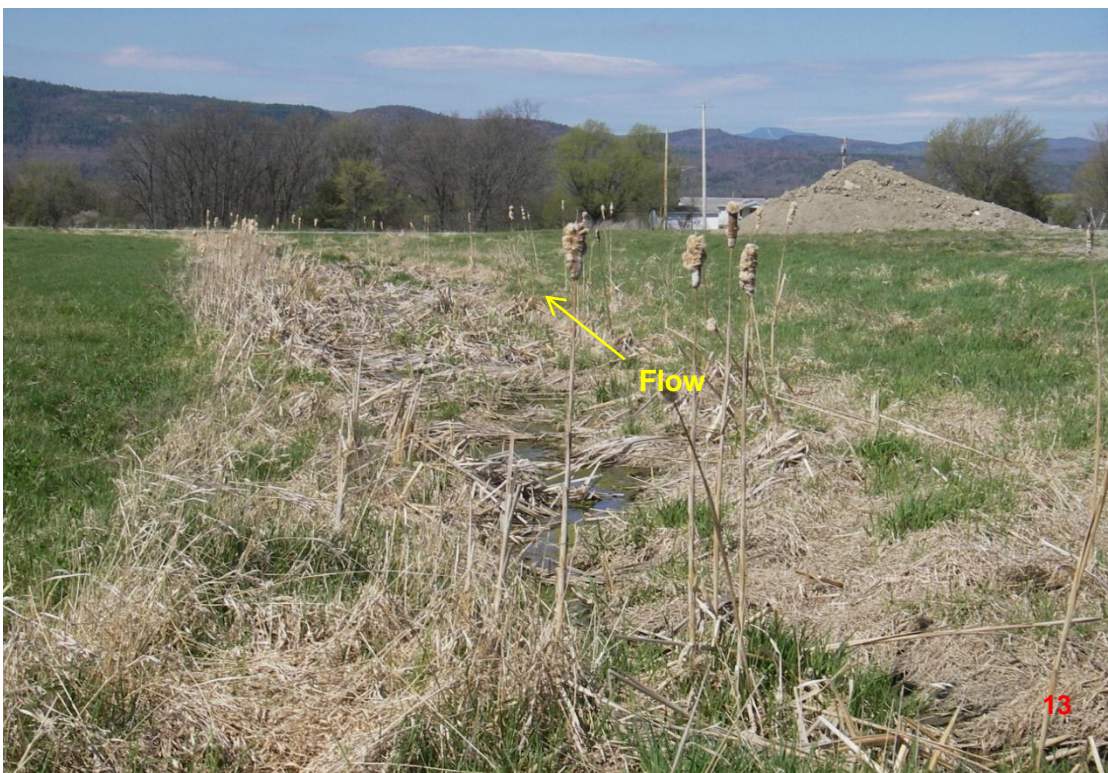
Picture 13 – Champlainside Farm, Bridport, VT – 4/19/12
Second vegetated drainage ditch (in picture 12) flowing west toward Lake Champlain.
